Project 3 area photos.

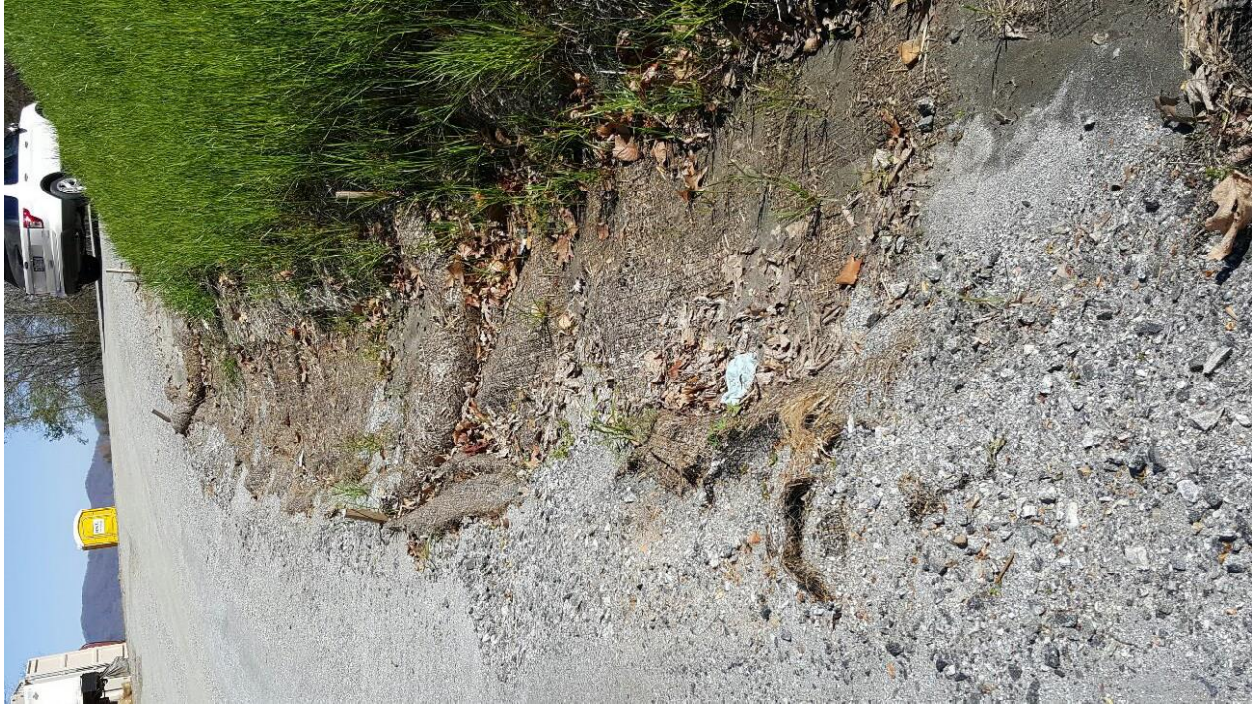
Project 3 area. Ditch line repairs required.

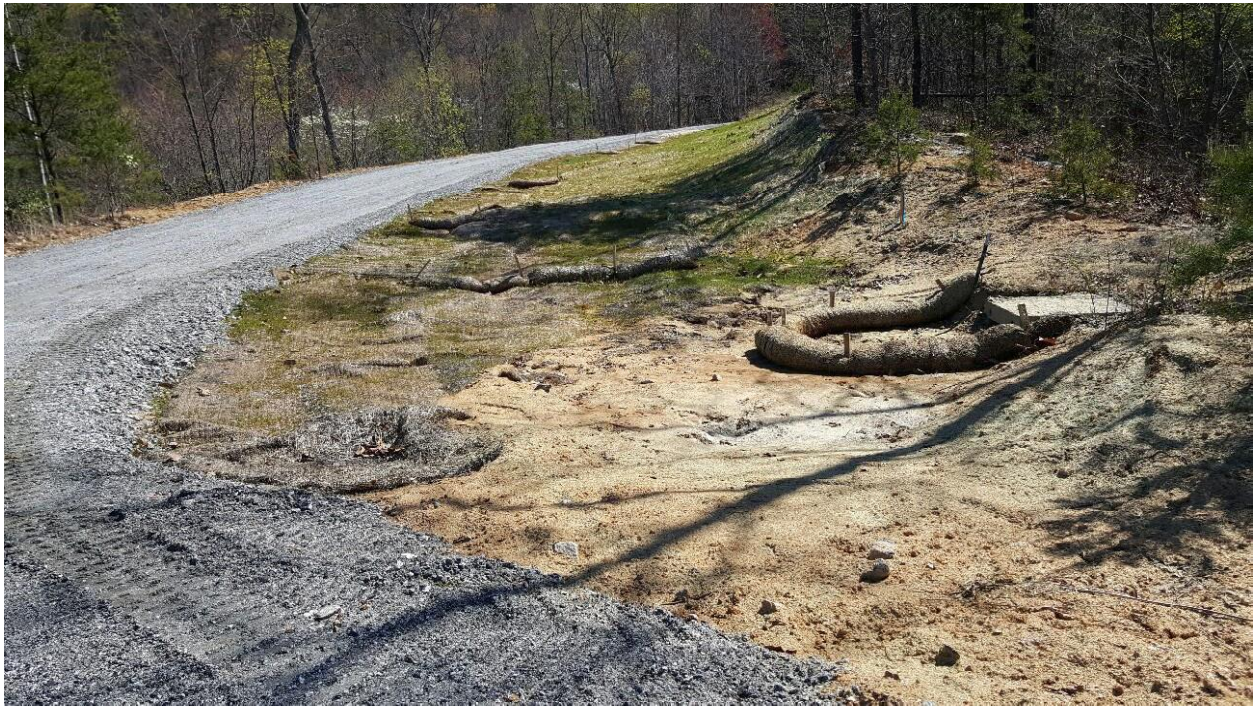
Project 3 area – Sediment removed and area hydro seeded, wattle inlet protection installed.

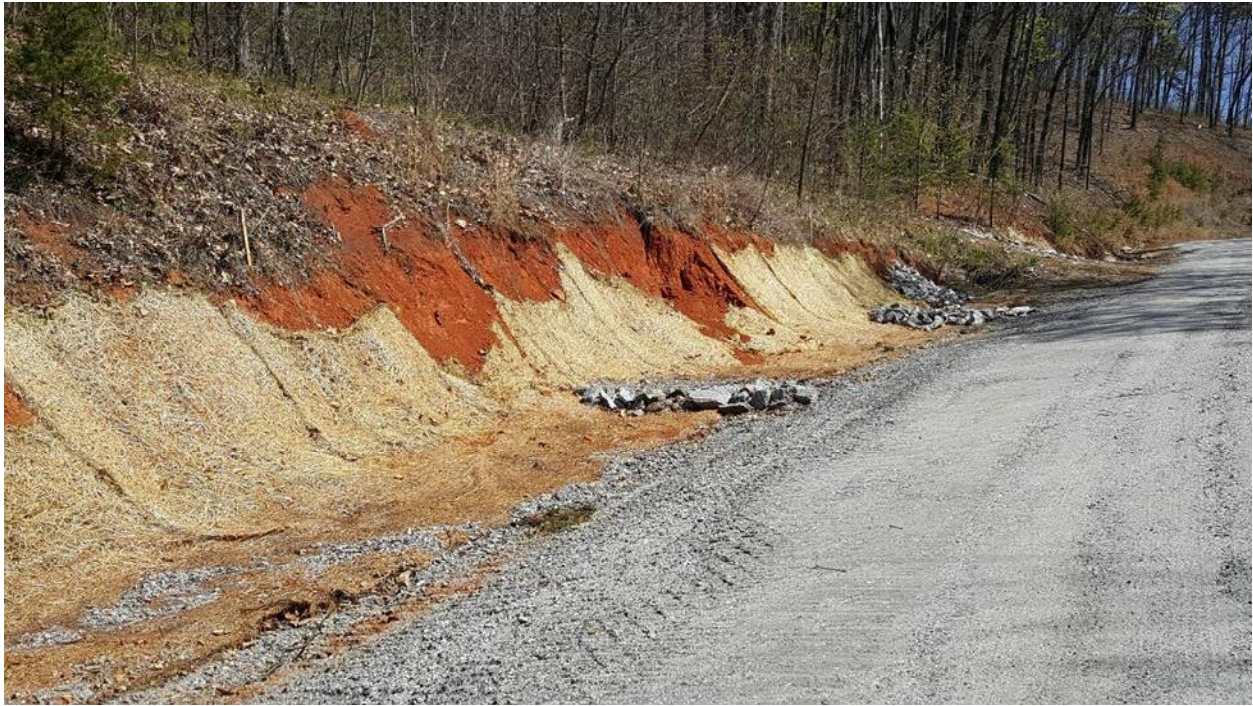
Slope repair required. Slope too steep to establish permanent vegetative groundcover, rolled erosion control product incorrectly installed.

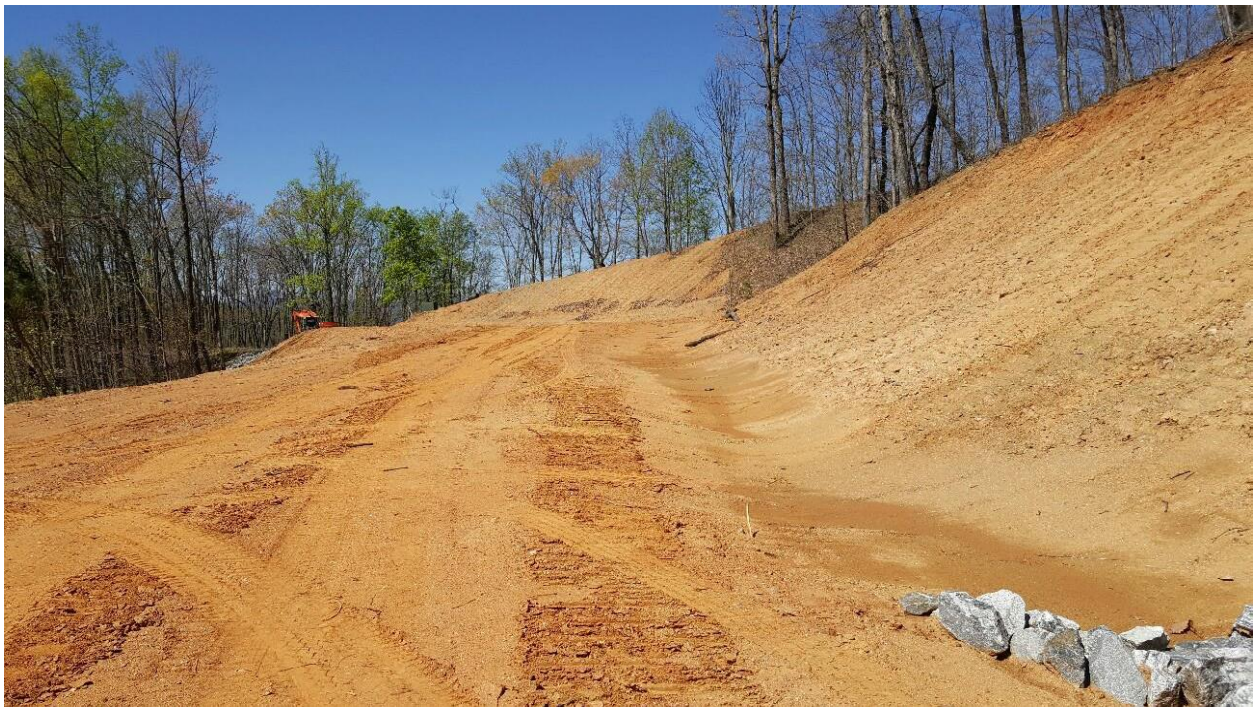
Eamon Drive grading and shaping on going. – Slopes hydro seeded.

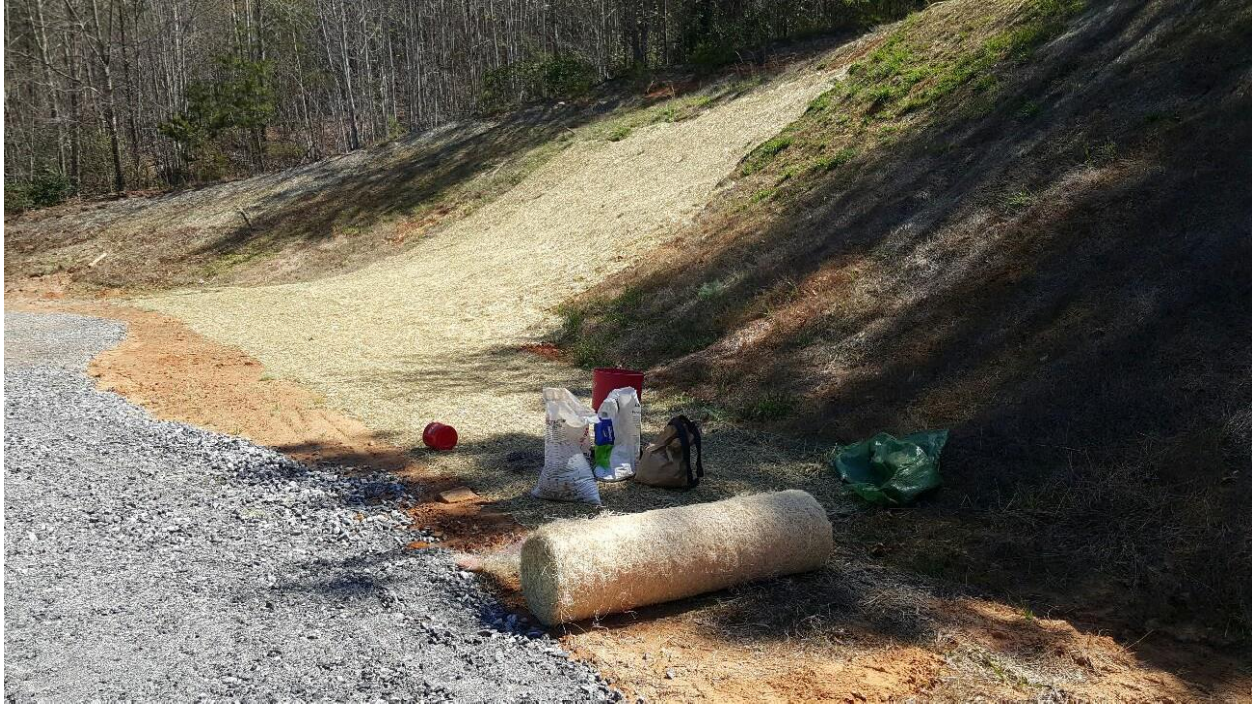
Slope repair. Rolled erosion control product installed on slope, ditch line shaped and excelsior matting installed on road shoulder. Project 2 area by Dalziel Enterprises.

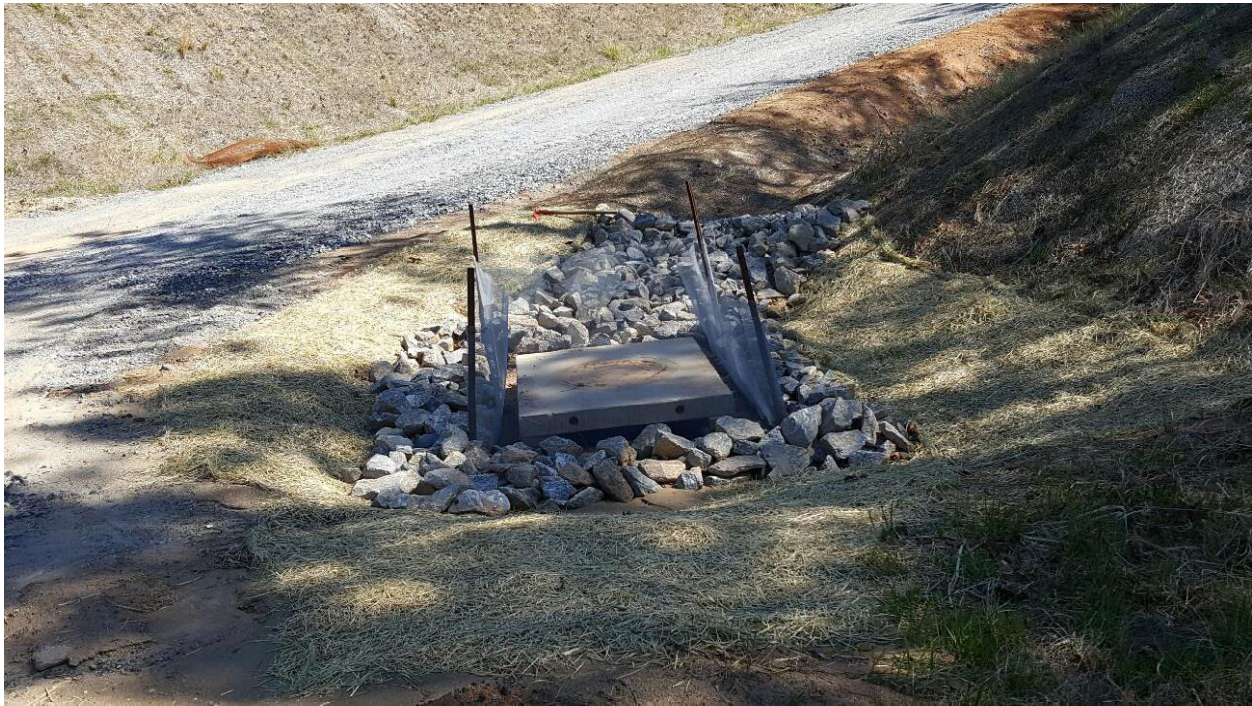
Drop Inlet area repair and restoration. Project 2 area by Dalziel Enterprises.
